**INVESTIGATION OF PAVEMENT CRACKING ON SR-4 AND  
DEMONSTRATION OF THE MULTI-HEAD BREAKER  
IN FRACTURING REINFORCED CONCRETE PAVEMENTS  
BEFORE ASPHALT OVERLAY**

Final Report

State Job Number 134196

May 2006

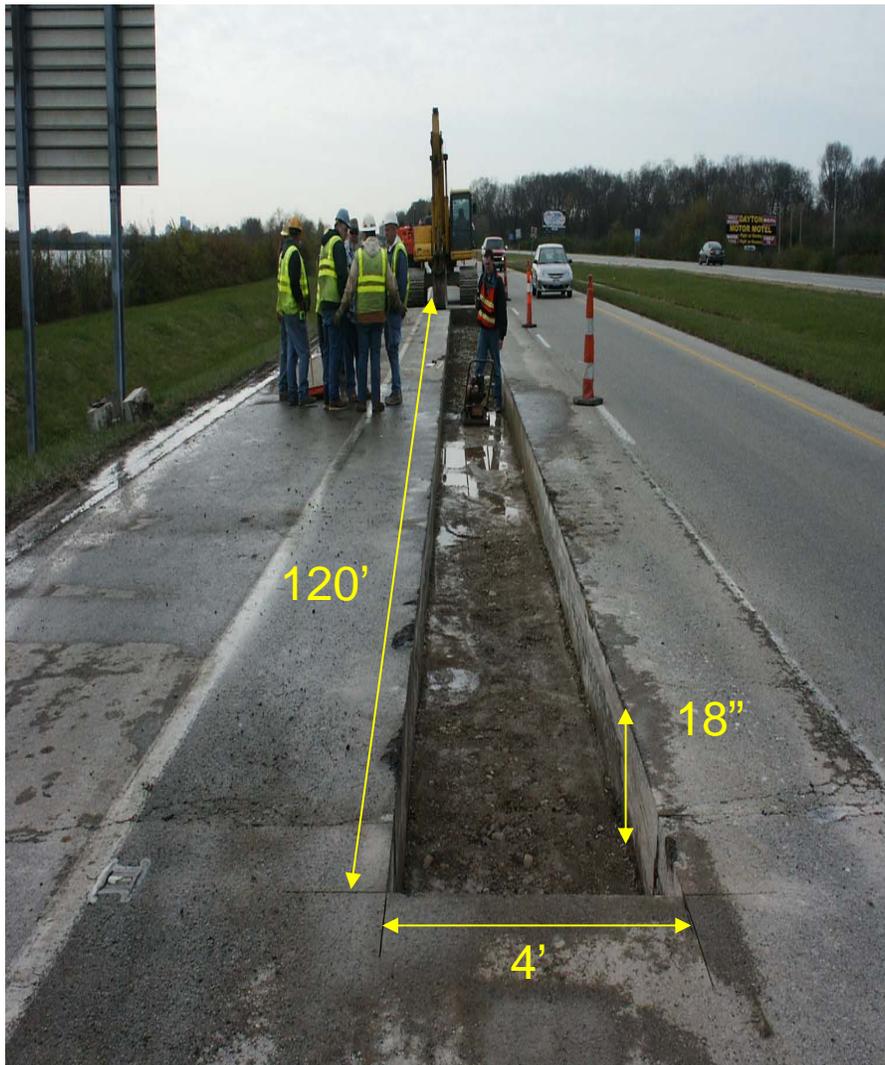
**Figure 8. Test Pit on SR-4, Montgomery County, Mile 22.7-22.8**

To permit a detailed examination of the condition of the fractured concrete, a large test pit was constructed in the center of the outside lane on one of the B/S test sections (Figure 8). The substantial length of the pit (120 feet) ensured that a representative sample was obtained for the condition evaluation.

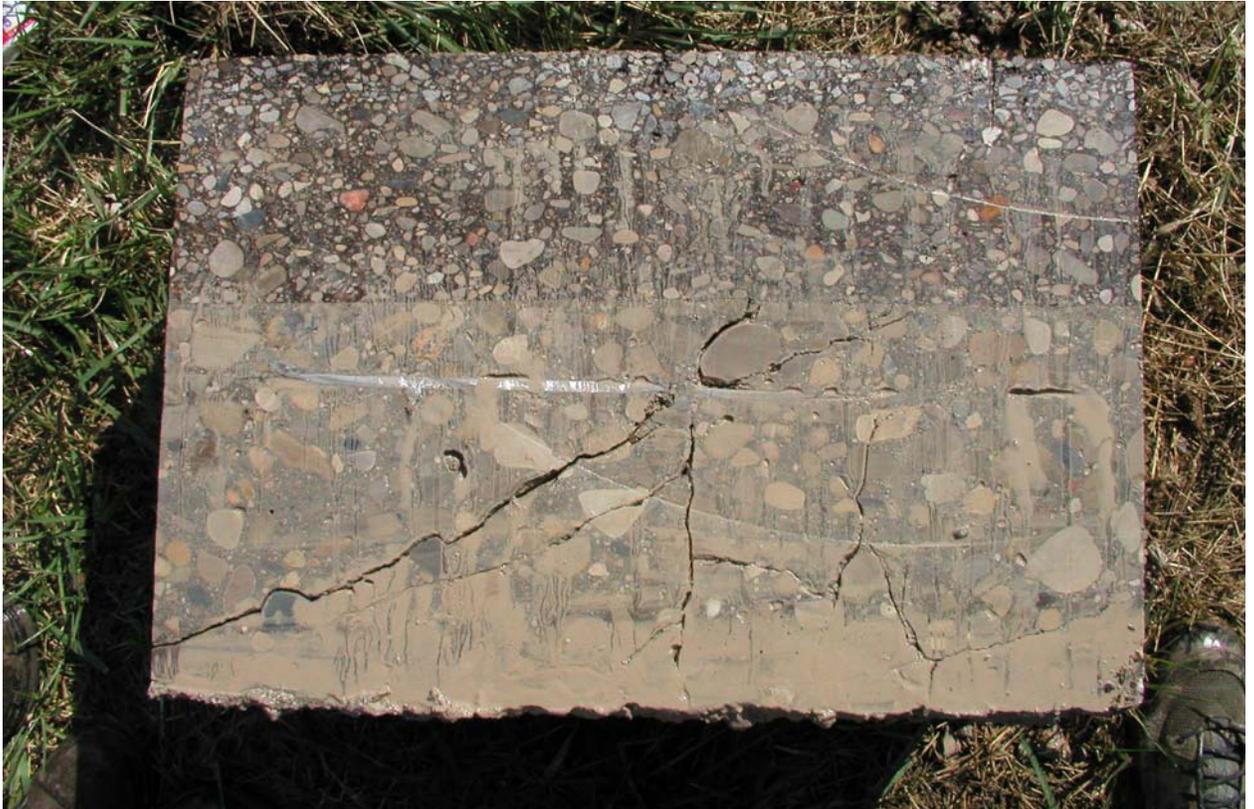
**Figure 9. Sample Collected for Detailed Inspection**

The sequence of operation for constructing the pit involved layout, saw-cutting, and pavement removal using a backhoe. Several large, square-cut samples were removed intact for detailed inspection (Figure 9). After the sides of the pit were cleaned by water washing, the pavement around the entire perimeter of the pit was examined to assess the nature and extent of pavement fracturing and reinforcing steel debonding.

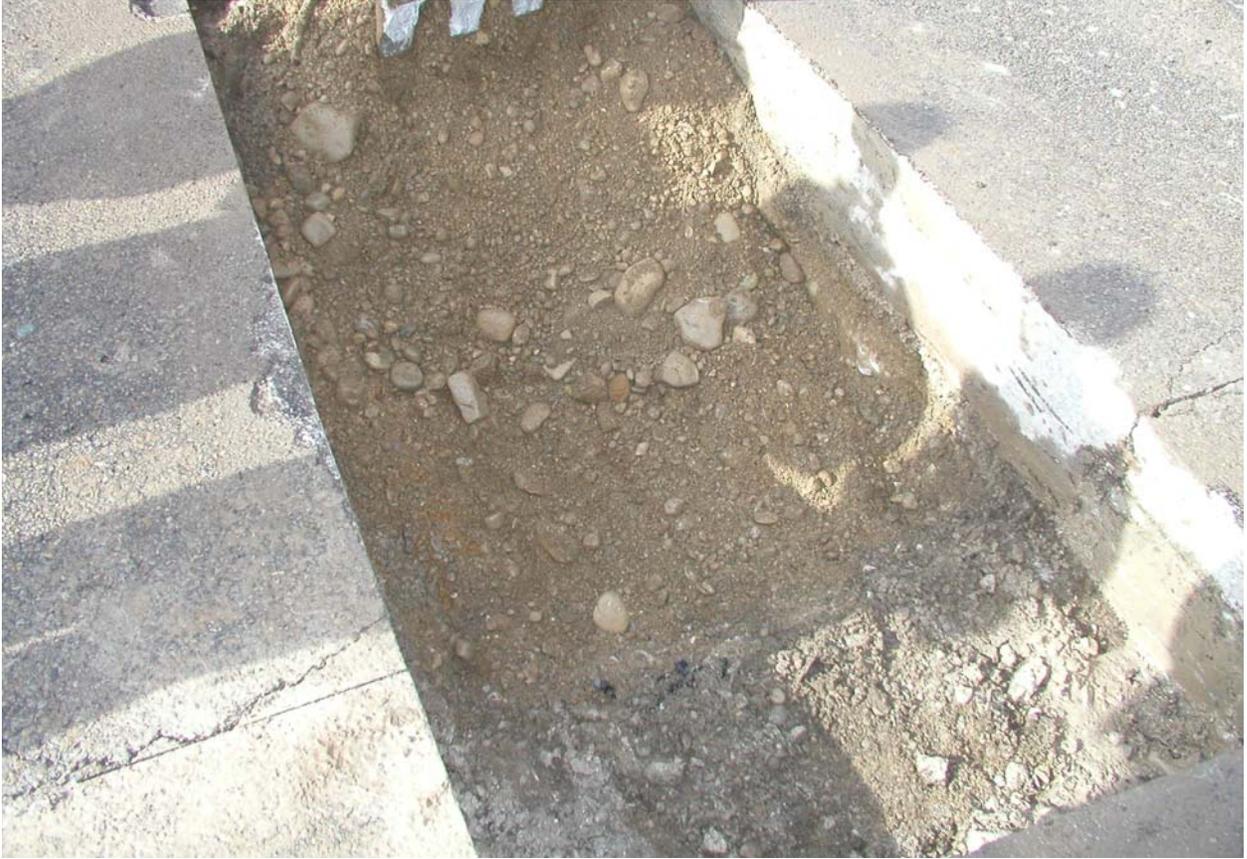
**Figure 10. Subgrade Exposed for DCP Test**

The subbase layer was examined and tested for its support values using a Dynamic Cone Penetrometer (DCP). This 6” layer was then removed to expose the subgrade for similar testing (Figure 10).

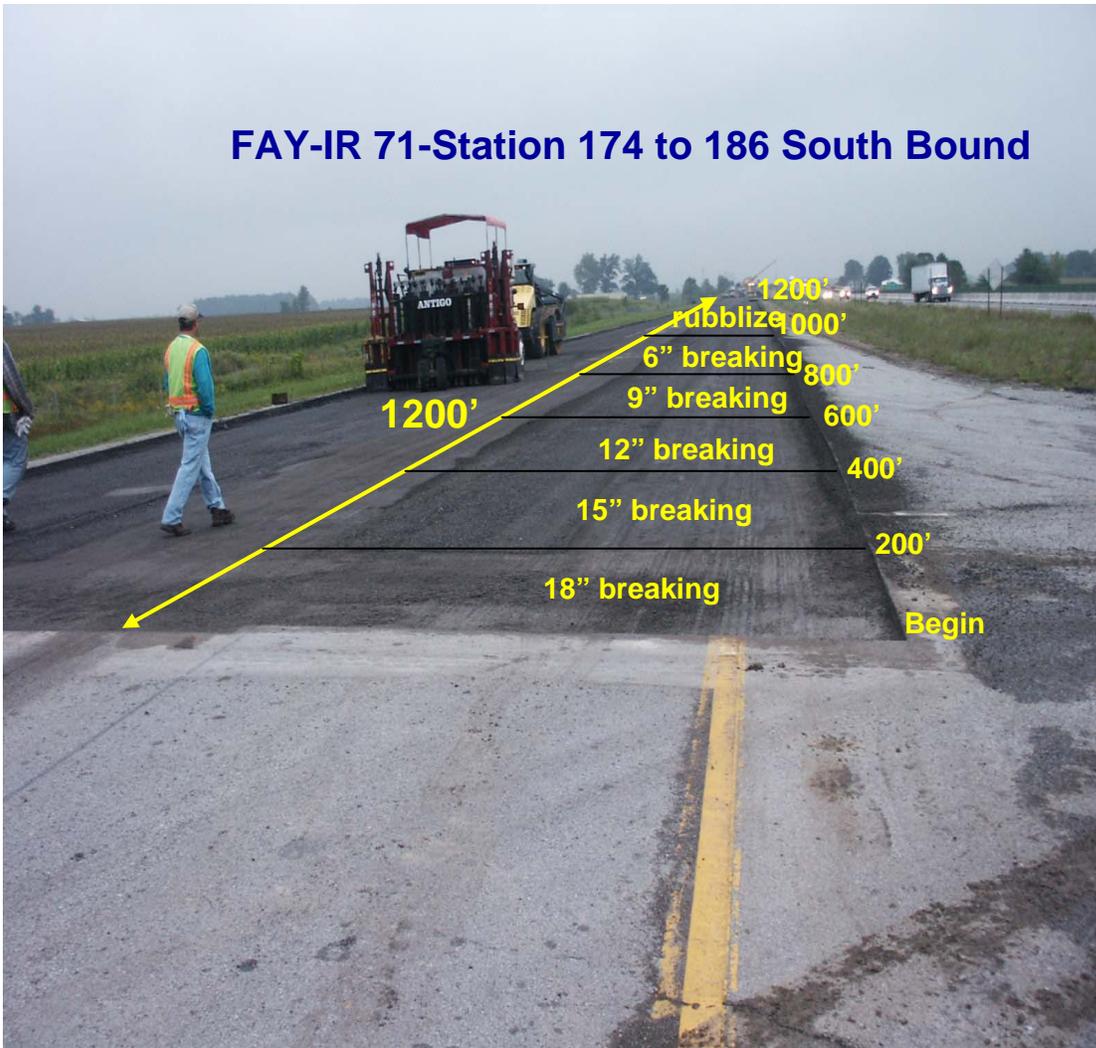
**Figure 17. MHB Demo Section, FAY 71-Station 174 to 186, Southbound Lane**

As shown in Figure 17, for each of the first five sections, the contractor was asked to produce a fracture pattern with a nominal target particle size of 18, 15, 12, 9 and 6 inches, respectively; the last section was to be rubblized in conformance with ODOT specifications.

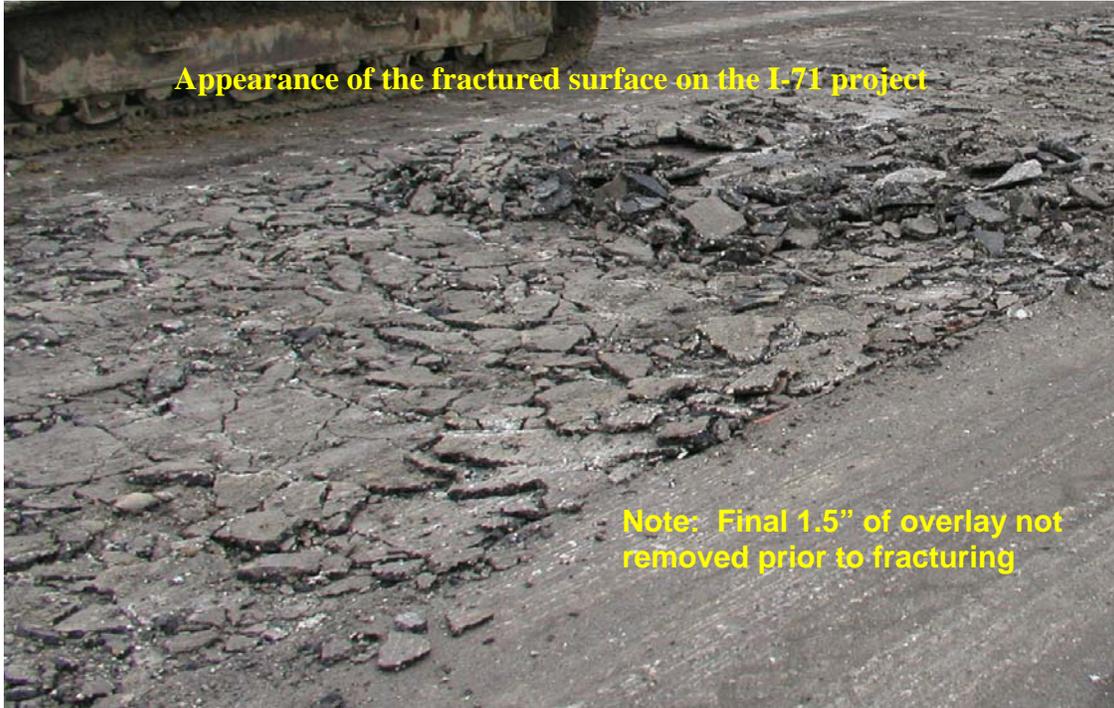
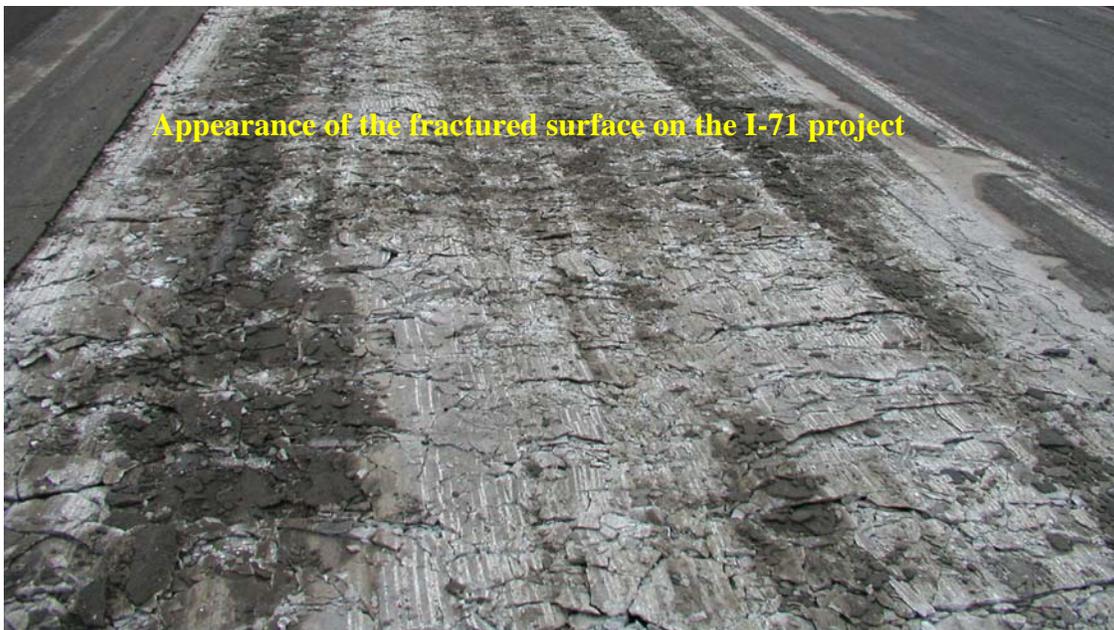
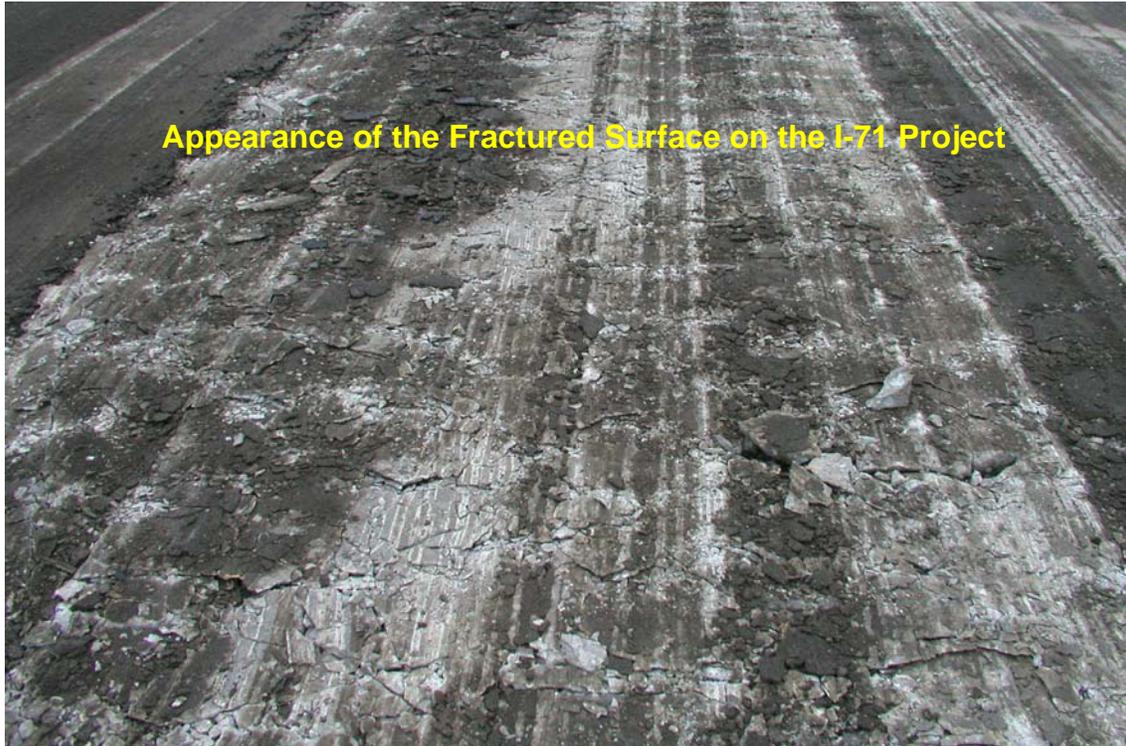
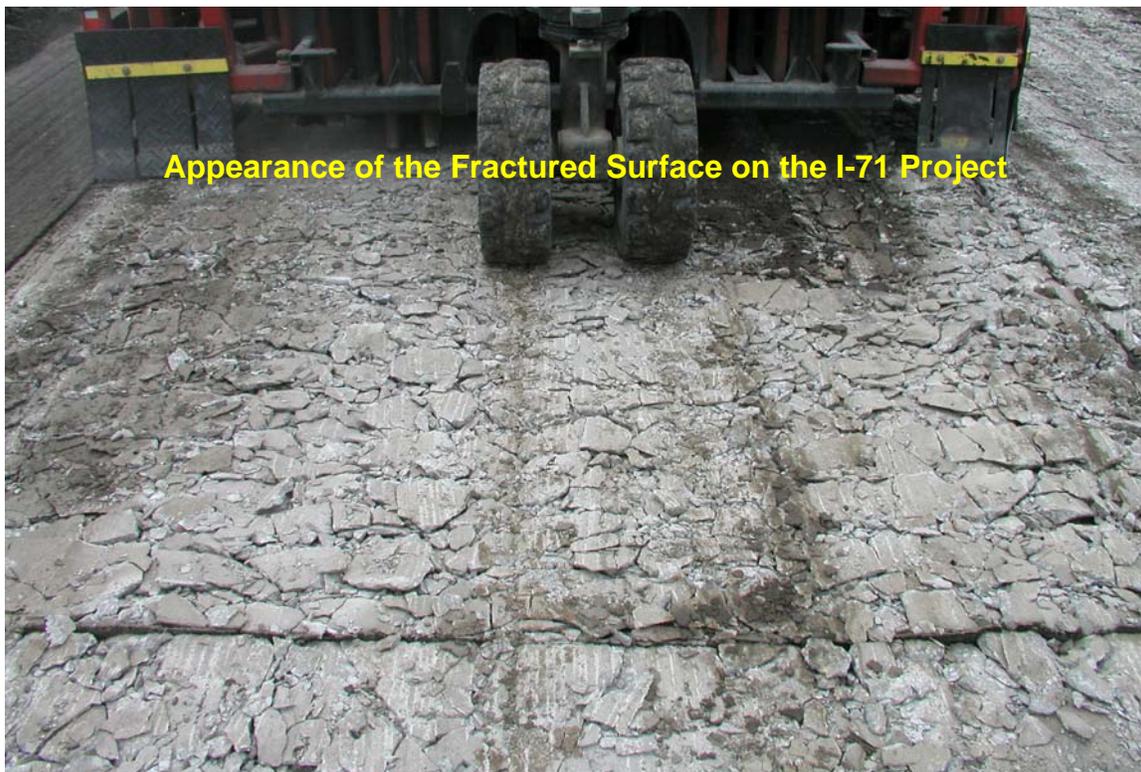
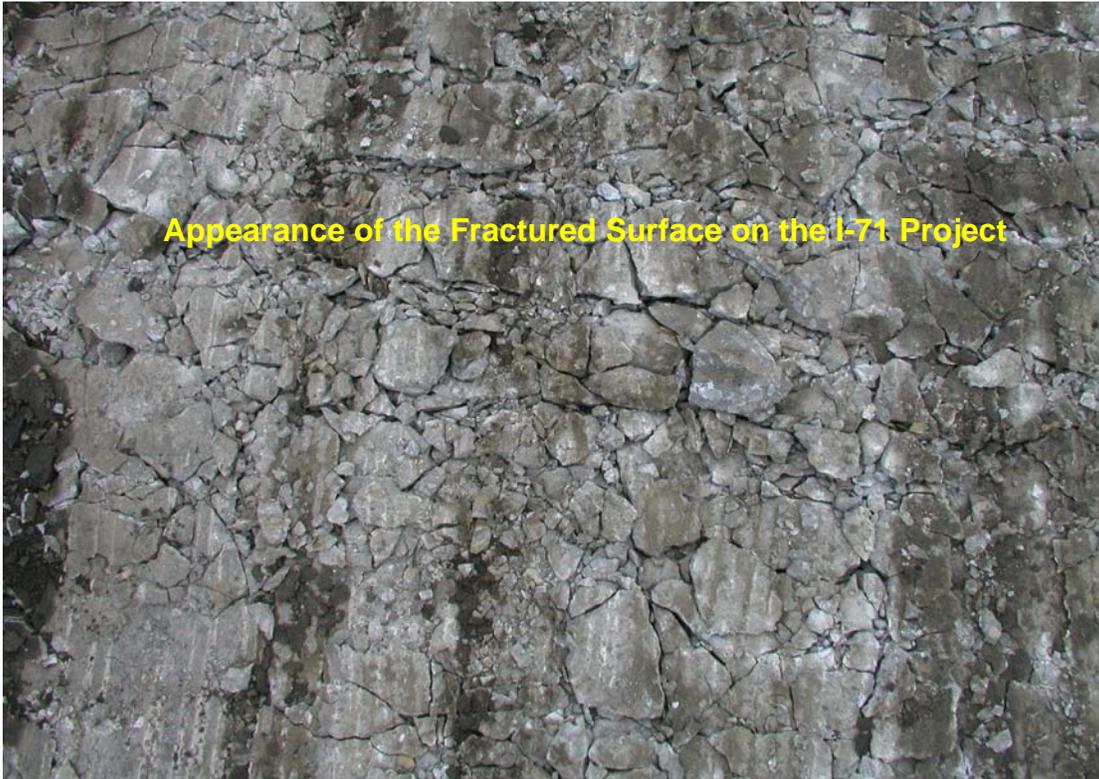
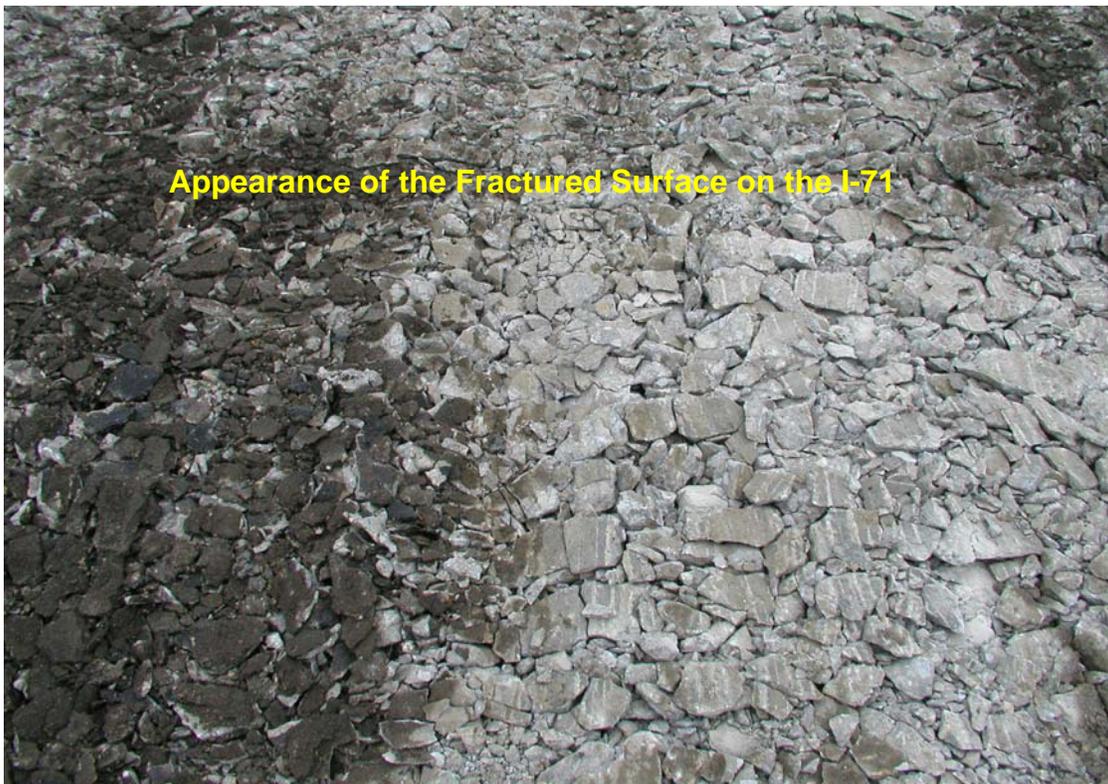
The appearance of the fractured pavement surface on each of the I-71 test sections is shown in Figures 20-25; the rubblized surface on I-70 is shown in Figure 26. As shown in these photos, on both projects, the surface appearance suggested that the desired particle sizes were indeed being obtained, with only a minimum of oversized material. However, once the test pits were opened, it was immediately obvious that on the I-71 project, a significant amount of large, un-cracked pieces were being produced (Figures

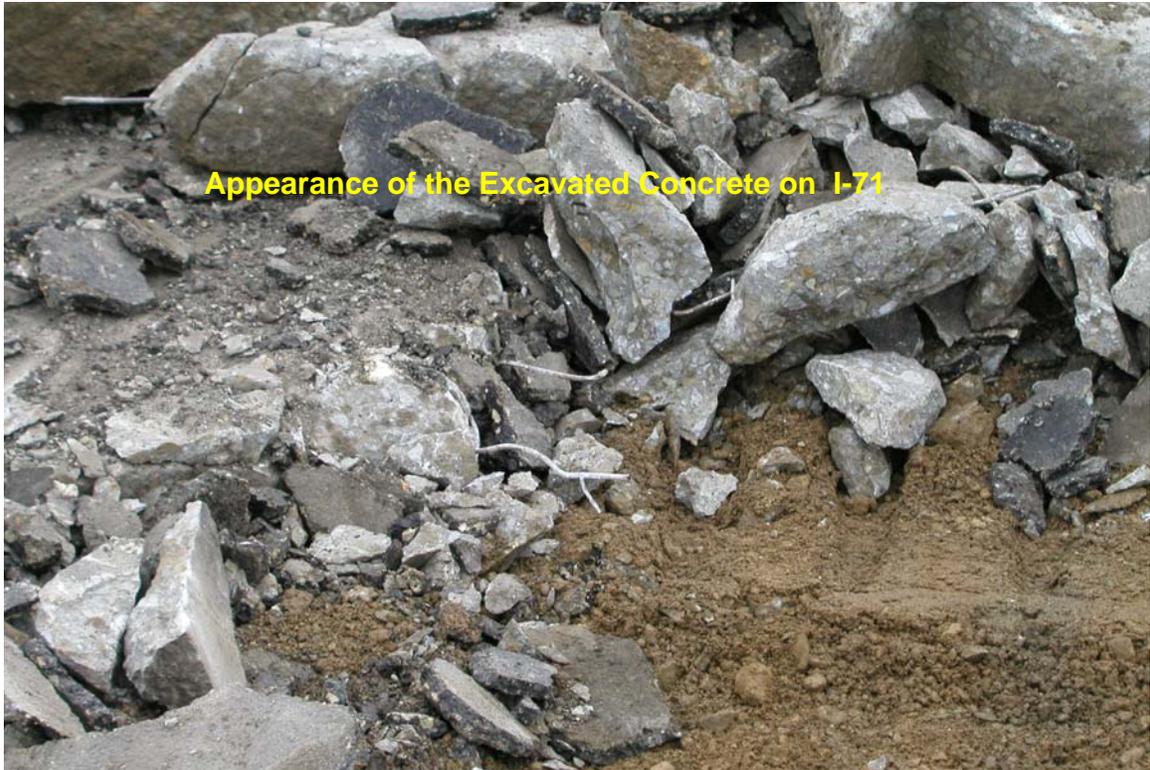
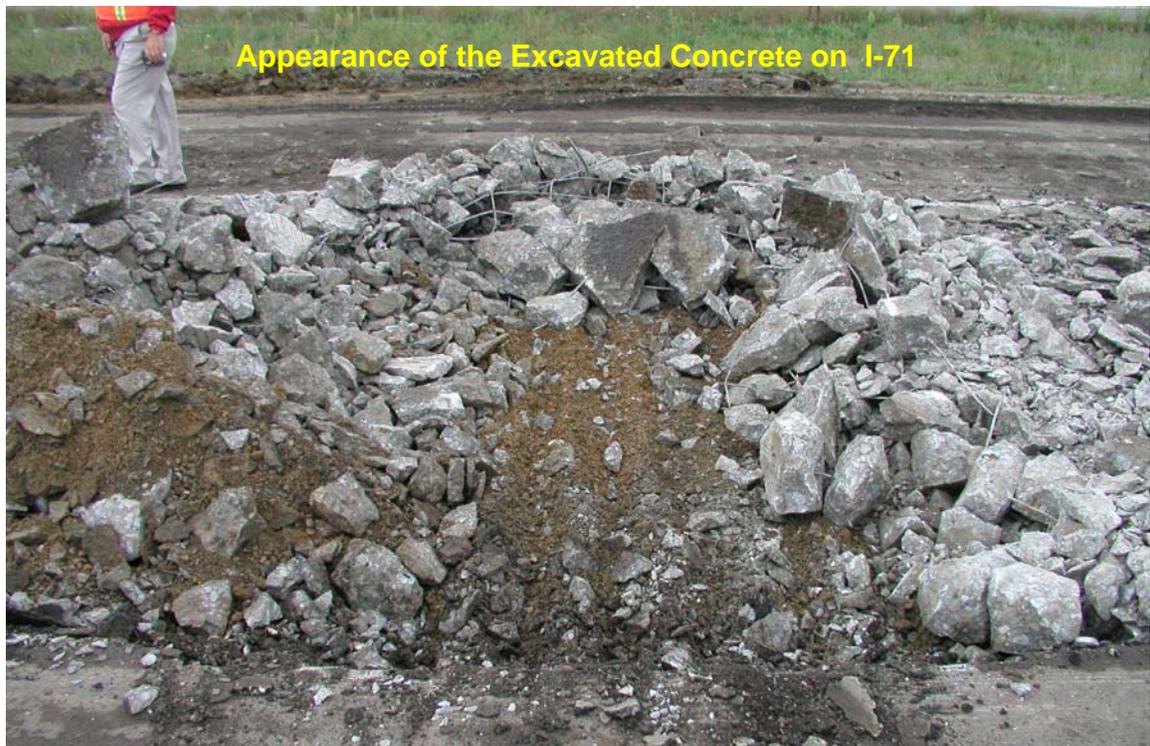
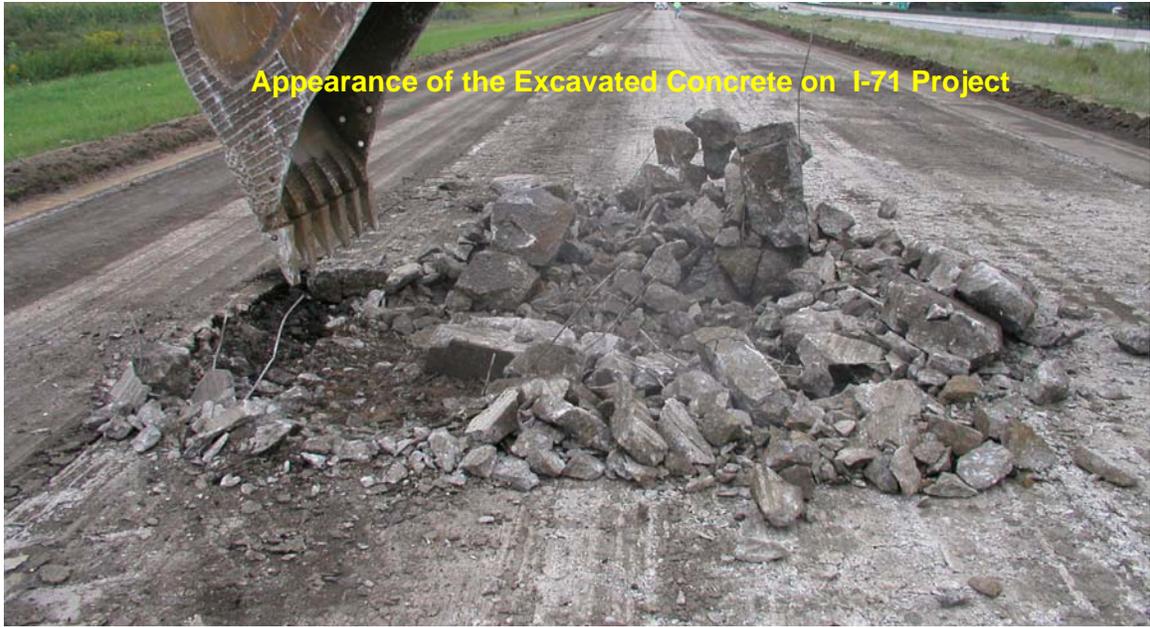
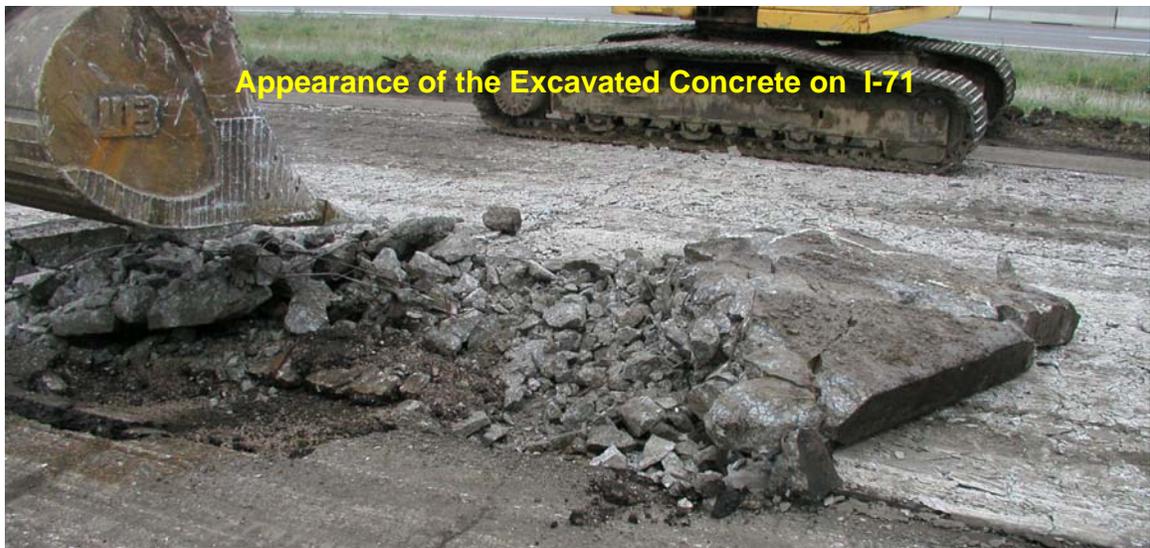
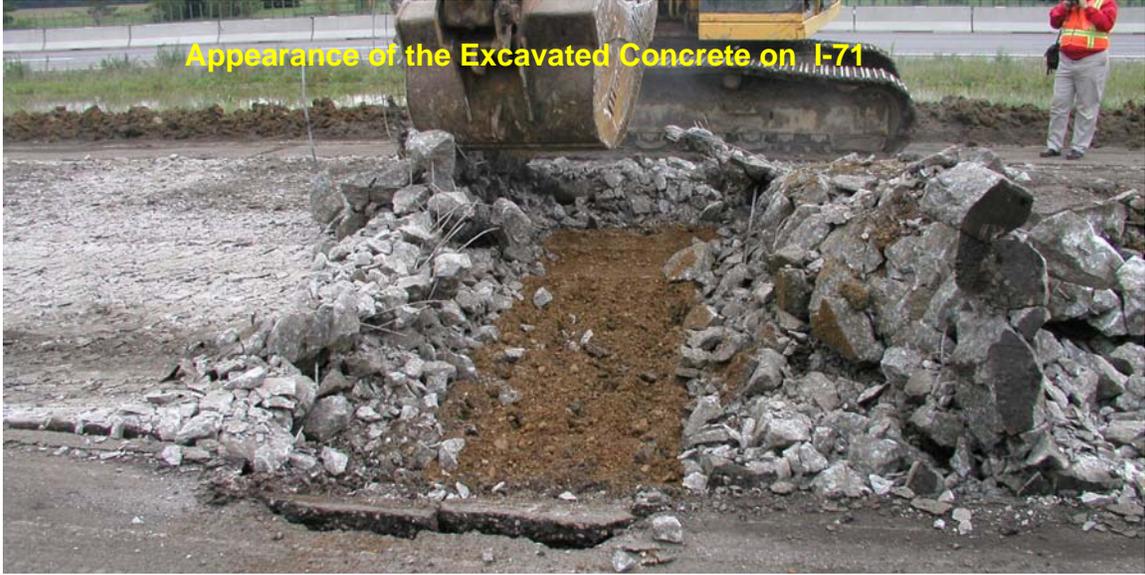
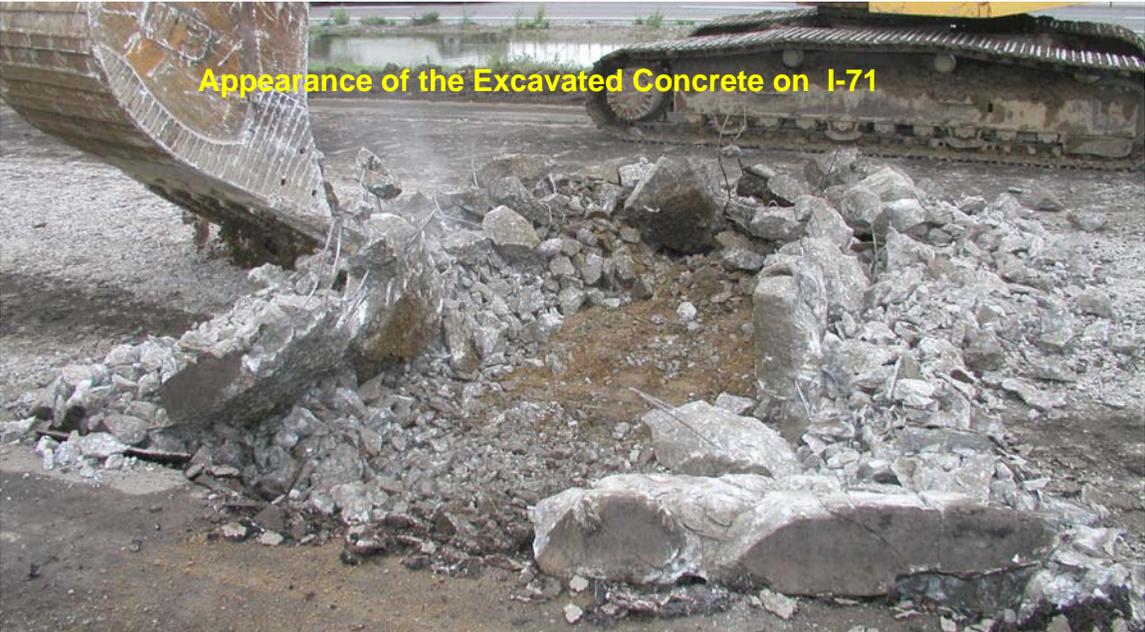
27-32). This was generally not the case on the I-70 project; there, the initial visual inspection of the excavated concrete revealed relatively few overly large pieces (Figures 33, 34).

As shown in Table 2, for each of the six test sections, the portion of the slab above the reinforcing steel was broken into fragments which were typically no larger than the desired target size. Below the steel, however, most of the fragments were significantly larger than the target size. Throughout the project, the maximum particle size was in a narrow range of about 20" x 20" to 22" x 24". Similarly, the size of a "typical" fractured particle in the portion of the slab below the steel varied very little from one test section to the next, commonly being about 9" x 12".

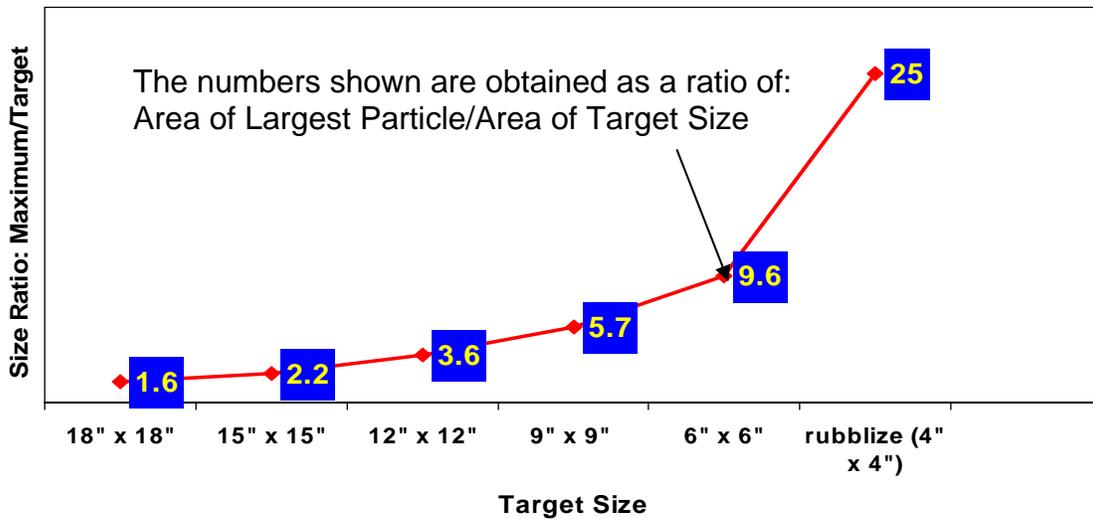
**Figure 36. Size Ratio of I-71 Slab Fragments**

The disparity between the target size and observed maximum size of fractured particles below the reinforcement on I-71 is shown graphically in Figure 36.

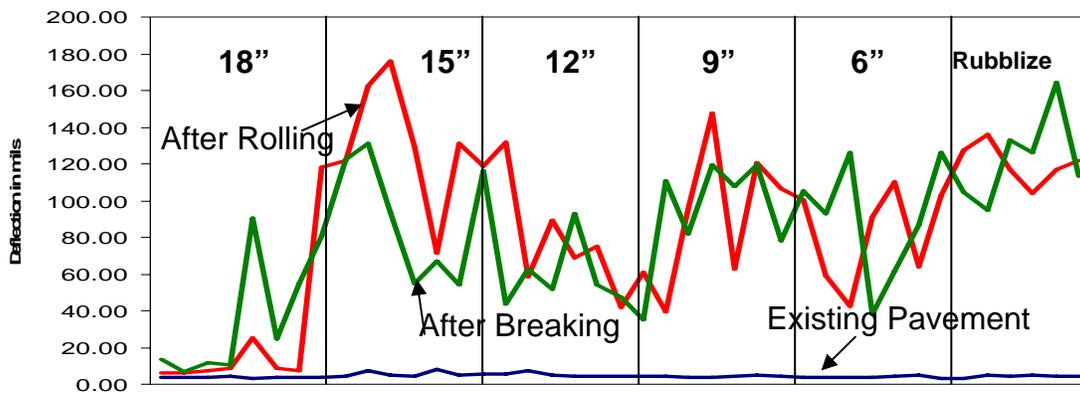
**Figure 38. Variation in Maximum Deflection on the I-71 Project**

Figure 38 shows the variation in maximum deflection value along the I-71 project on the existing pavement, on the fractured layer after breaking and after rolling for each breaking pattern. As it can be seen, the deflection value of the existing pavement was very consistent along the project indicating a structurally homogeneous section. As expected, the deflection values increased significantly after breaking. However, there is no definite relationship between the observed maximum deflection and the target fractured particle size. A similar observation can be made using the deflection values after rolling. Thus it is concluded that, the deflection values increased due to breaking but the variation in maximum surface deflection values did not significantly change due to the breaking pattern.

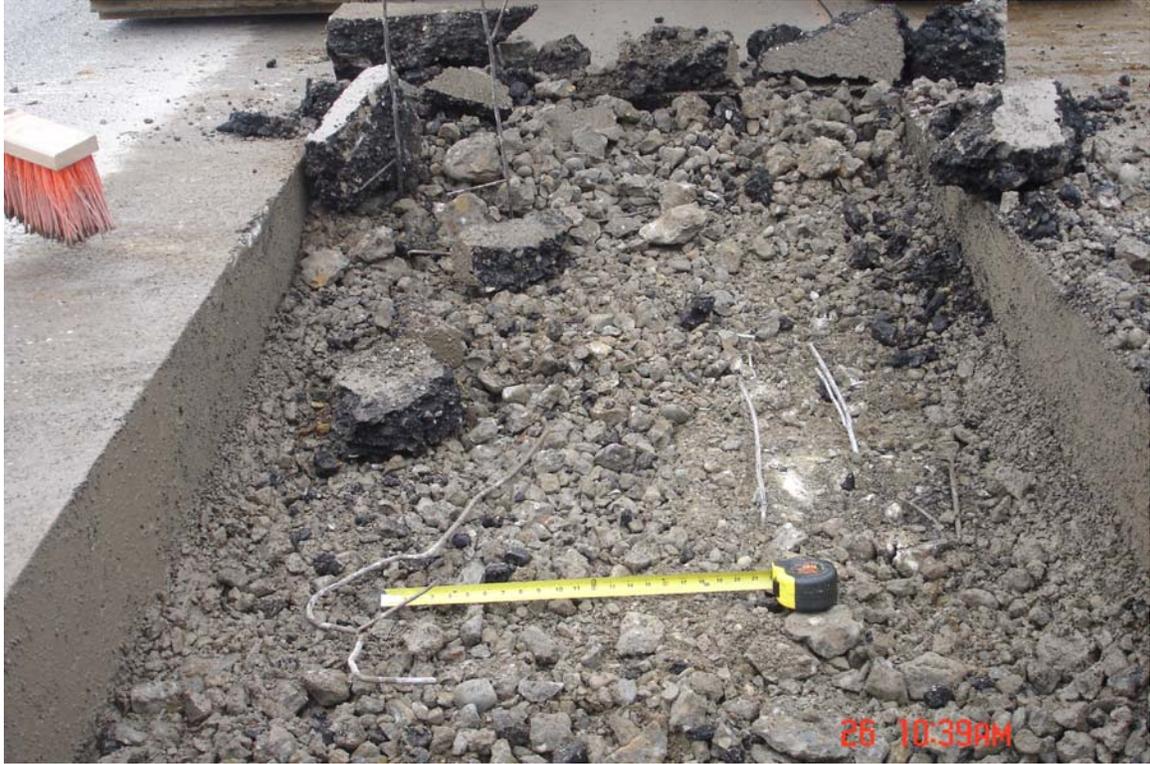
**Figure 42. Distribution of Particle Sizes on the COS-36 Project**

Figures 42 and 43 are photos illustrating the size distribution of the fractured particles in the test pit. As shown in Figure 42, the pieces near the surface appeared to consistently be in the 1-2” range required by ODOT specifications. Similarly, throughout the depth of the slab, all of the fractured pieces appeared to be smaller than the 6” maximum size permitted by the rubblized specification, with about 90% being in the range of 2-4” in size (Figure 43).

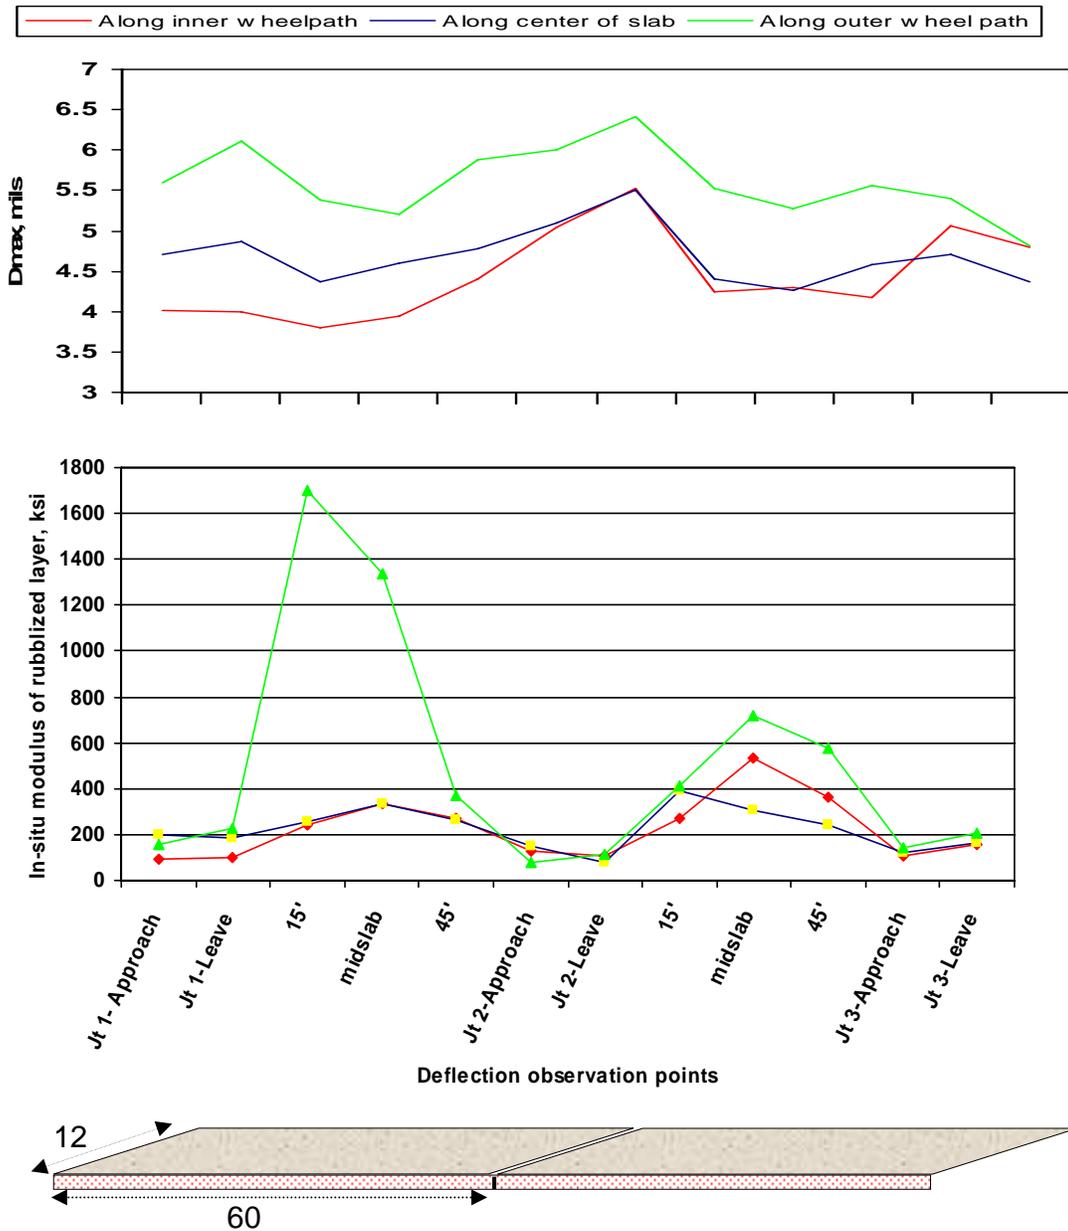
Figure 49. COS36-Variation in  $D_{max}$  and Modulus of Rubblized Layer

consistency of the RPB in breaking the concrete slabs. The FWD deflections were analyzed to estimate the in-situ resilient modulus of each layer. A backcalculation analysis was conducted, using *EVERCALC* program. The in-situ modulus of rubblized layer at various locations, along with a plot of maximum deflection values are presented in Figure 49.

The maximum deflection values ranged from 3.8 to 6.42 mils. In general, the maximum deflections follow the expected pattern, with the deflections tending to increase outward from the centerline and closer to the pavement edge. Although maximum deflection can be used to compare the structural condition of two pavements, it does not indicate to what degree each layer is contributing to the surface deflection in a multilayer system. On the other hand, an analysis of the shape of deflection bowl can adequately describe the contribution of each layer and resulting stress conditions in a pavement system. To that effect, the modulus values reflect the structural condition of pavement layers. As seen in figure 49, the range of modulus of rubblized layer is 76ksi to 1700ksi with an average value of 317ksi. At two locations, the modulus values along the outer wheel path were significantly higher than those along inside lines. The residual effect of reinforcement at these locations may have caused an increase in the modulus values. It is interesting to note that, except for these two values, all other data points lie within a narrow range indicating very consistent structural condition of the rubblized layer. The fact that the modulus values along and across the pavement, at and near the joints, all remain within a reasonable limit supports performance claims by RPB.

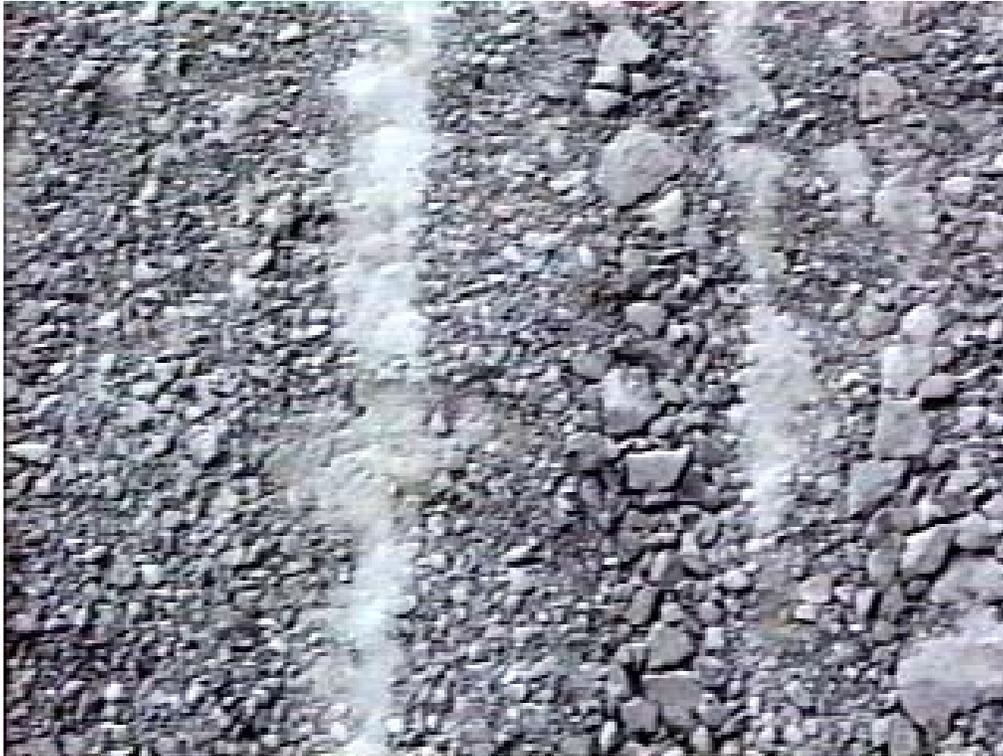
As observed on the ODOT test projects, the Arkansas tests indicated that the RPB equipment generally provided smaller particles at the surface of the rubblized layer and throughout the depth of the fractured slab (Figures 50, 51).

**Figure 50. Distribution of Surface Particles on RPB Project in Arkansas**

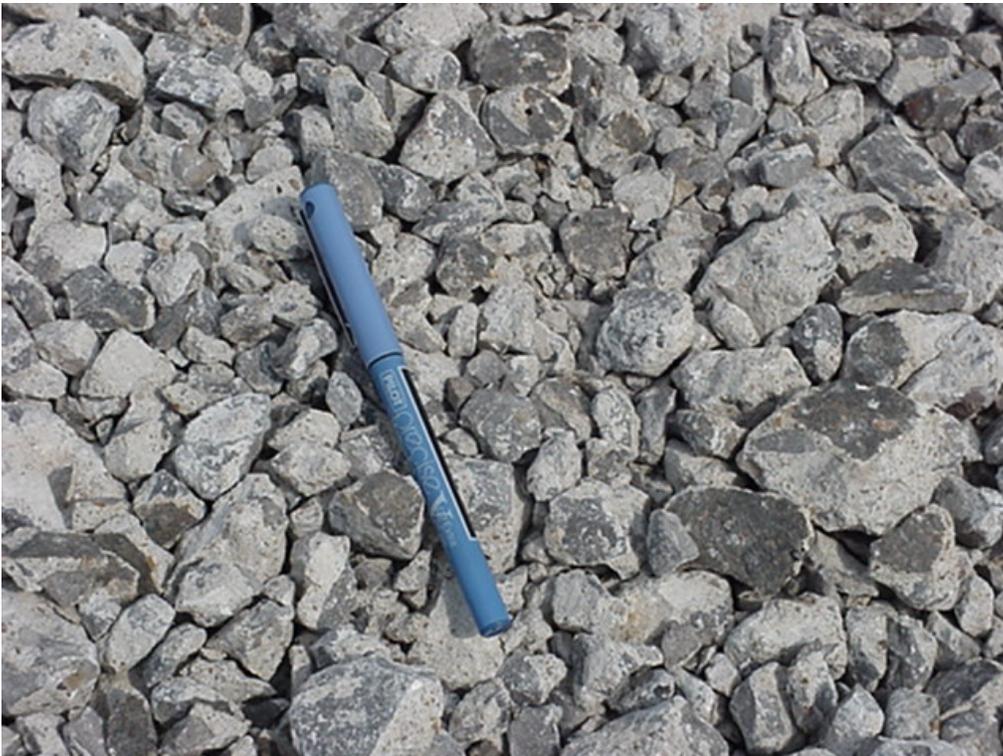
**Figure 51. View of Surface Particles on Arkansas MHB Project**

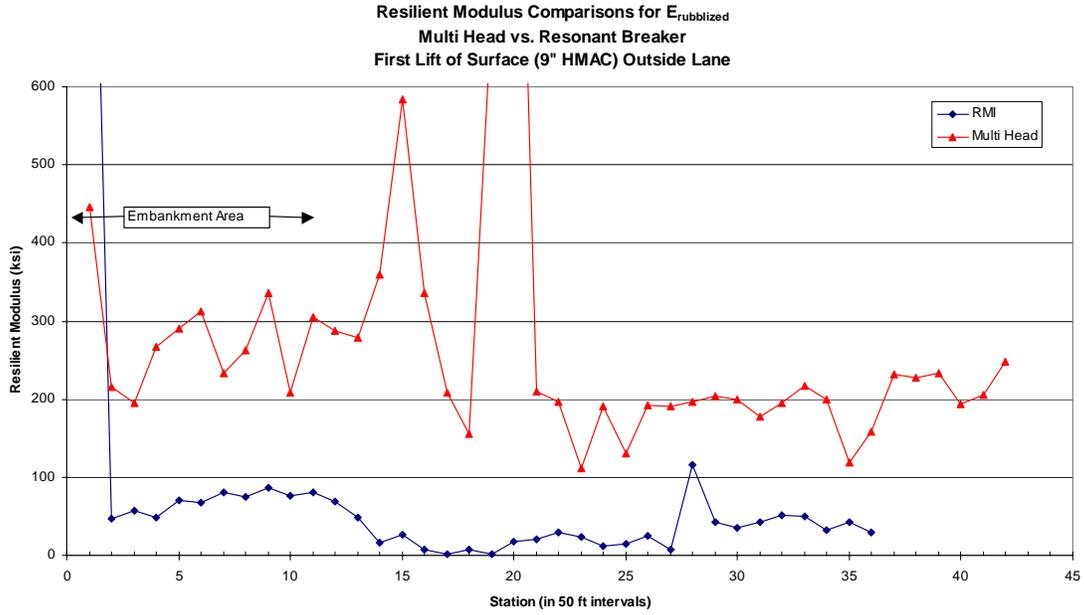
Deflection tests were conducted to compare the structural characteristics of the test pavements. The results of the Arkansas deflection testing on outside lanes are plotted in Figures 52 and 53. As shown, the modulus values for the rubblized layer fractured with the RPB are lower and less variable than those produced by the MHB. This result is consistent with the smaller, more uniform particle size observed for the RPB operation.

On the Meniffee project, each of the fracturing techniques produced a rubblized layer whose stiffness was less than the 100ksi threshold value beyond which reflection cracking is expected to occur [9]. On the Brinkley project, however, *all* of the deflection test results on the MHB test section were greater than the 100 ksi threshold, and averaged 175 ksi (Table 3). In contrast, all but one of the measurements on the RPB test sections was less than the critical value, and average 67 ksi.

**Figure 52. Comparison of Resilient Modulus values for the Brinkley Project [22]**

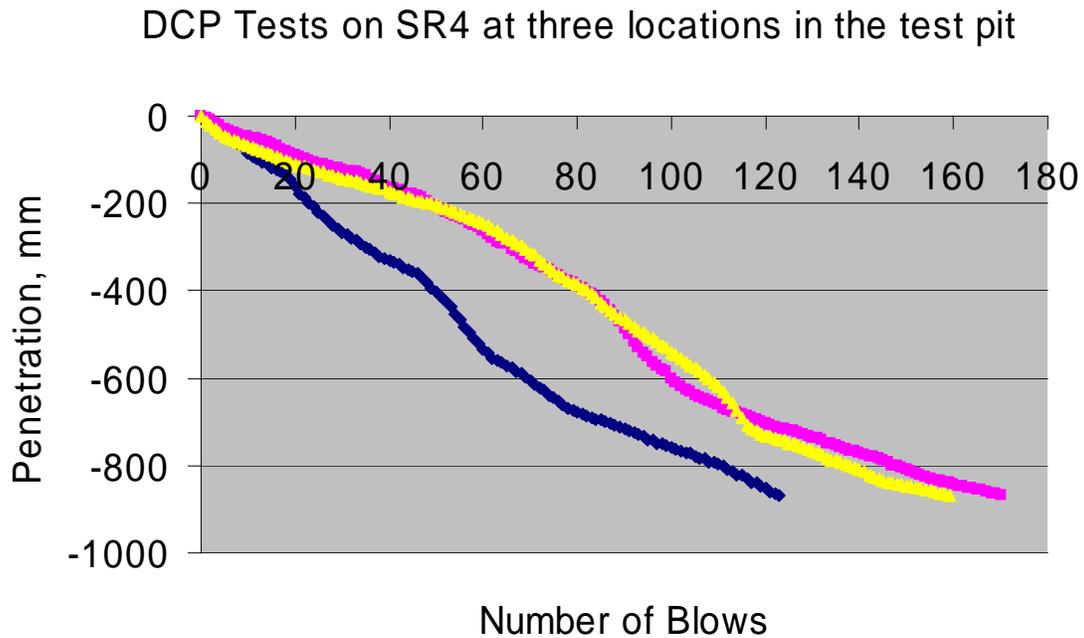
Three locations within the test pit on SR-4 were selected for DCP testing. The tests were conducted on the subbase and subgrade layers. Penetration readings were taken with each blow of the drop weight. Testing ceased when the penetration depth for each blow was less than 1 mm or the cumulative penetration depth approached one meter.

Plots of penetration versus a corresponding number of blows were generated for each of the DCP test location. The results are presented in the figure below:
